## STENOSIS OF A BIOPROSTHETIC TRICUSPID VALVE

*Houston Methodist DeBakey Heart & Vascular Center, Houston Methodist Hospital, Houston, Texas*

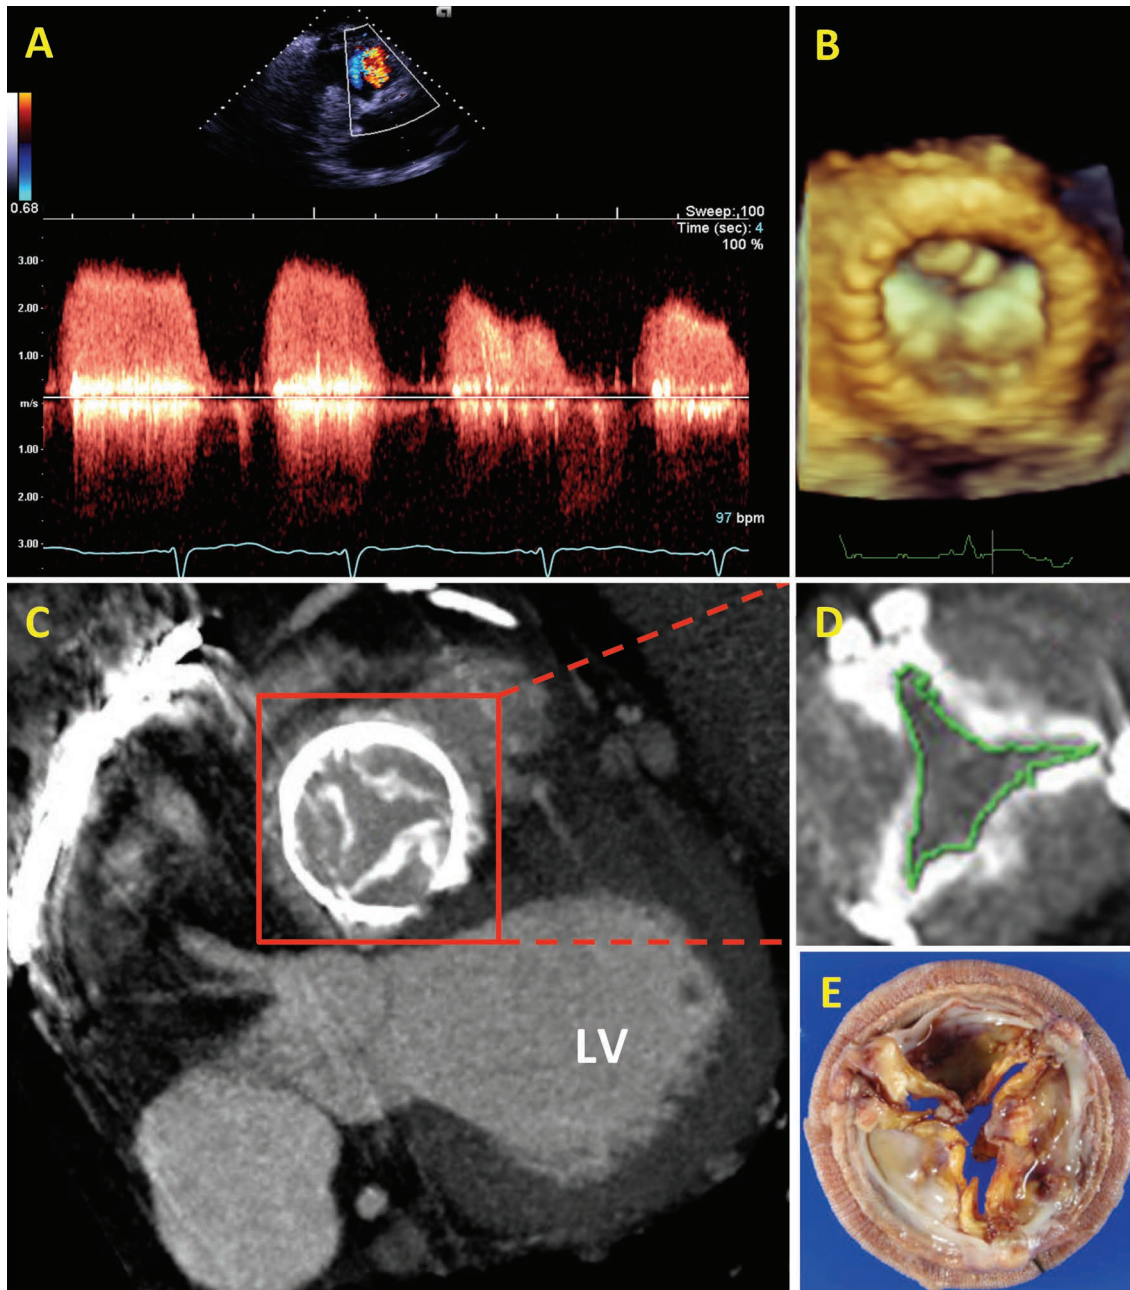
A 41-year-old female with tricuspid valve replacement presented to the Houston Methodist Hospital with dyspnea. (A) Spectral Doppler by transthoracic echocardiogram (TTE) revealed high velocity with rounded contour. (B) Three-dimensional (3D) transesophageal (TEE) image of the prosthesis during diastole.

(C) 64-multislice cardiac computed tomography demonstrated a degenerative prosthetic tricuspid valve with severely thickened and calcified leaflets. (D) Anatomic orifice area calculated by planimetry was found to be 1 cm<sup>2</sup> (green perimeter trace). (E) Excised valve showing the extent of valve degeneration.
