## EARLY POST-OPERATIVE DYSFUNCTION OF A MECHANICAL AORTIC VALVE

Methodist DeBakey Heart & Vascular Center, The Methodist Hospital, Houston, Texas

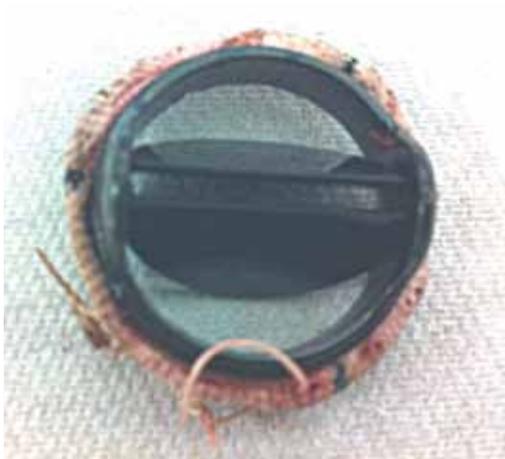
**Figure 4.** Photo of explanted valve showing restricted mobility of both leaflets.

Because of this acute prosthetic valve dysfunction, the patient once again underwent redo valve surgery. The mechanical valve was successfully explanted, and under direct inspection no apparent thrombus, suture, or tissue was identified on or around the valve. With manual manipulation, the explanted valve clearly demonstrated restricted leaflet opening (Figure 4). A new 21-mm bioprosthetic aortic valve was implanted, and postoperative echocardiogram demonstrated normal valve function and Doppler gradients. The patient was discharged home in stable condition.

We report a case of very early postoperative mechanical aortic valve obstruction. Restricted leaflet opening of prosthetic mechanical valves may be due to aberrant suture or pledget material, incomplete decalcification of the aortic annulus, thrombus (early or late), or pannus (late) formation. Any of these rare mechanisms of dysfunction tend to cause unilateral or asymmetric leaflet restriction in systole or diastole. In this case, multiple imaging modalities (echo Doppler, cinefluoroscopy, and CT) demonstrated acute systolic valve dysfunction involving both mechanical leaflets, however neither this noninvasive imaging nor direct inspection of the explanted valve could identify a macroscopic cause of the restricted leaflet motion. Possible explanations for acute mechanical valve dysfunction include mechanical valve failure (although the intraoperative TEE demonstrated normal prosthetic valve function) or possibly microthrombi at the pivot/hinges of the leaflets that could not be identified by routine imaging and visual examination. In this case, the explanted valve was returned to the valve manufacturer and thoroughly examined. That report indicated that “two of the recessed pivot areas contained thick coagulated blood,” and that after cleaning the explanted valve leaflets demonstrated normal function. In summary, we report a rare case of very early mechanical aortic valve dysfunction. The mechanism of prosthetic leaflet restriction in this case remains uncertain; however, we believe that microthrombi located within the leaflet pivot points (hinges) was likely a contributing factor.
