PROSTHETIC MITRAL VALVE THROMBOSIS

Houston Methodist DeBakey Heart & Vascular Center, Houston Methodist Hospital, Houston, Texas

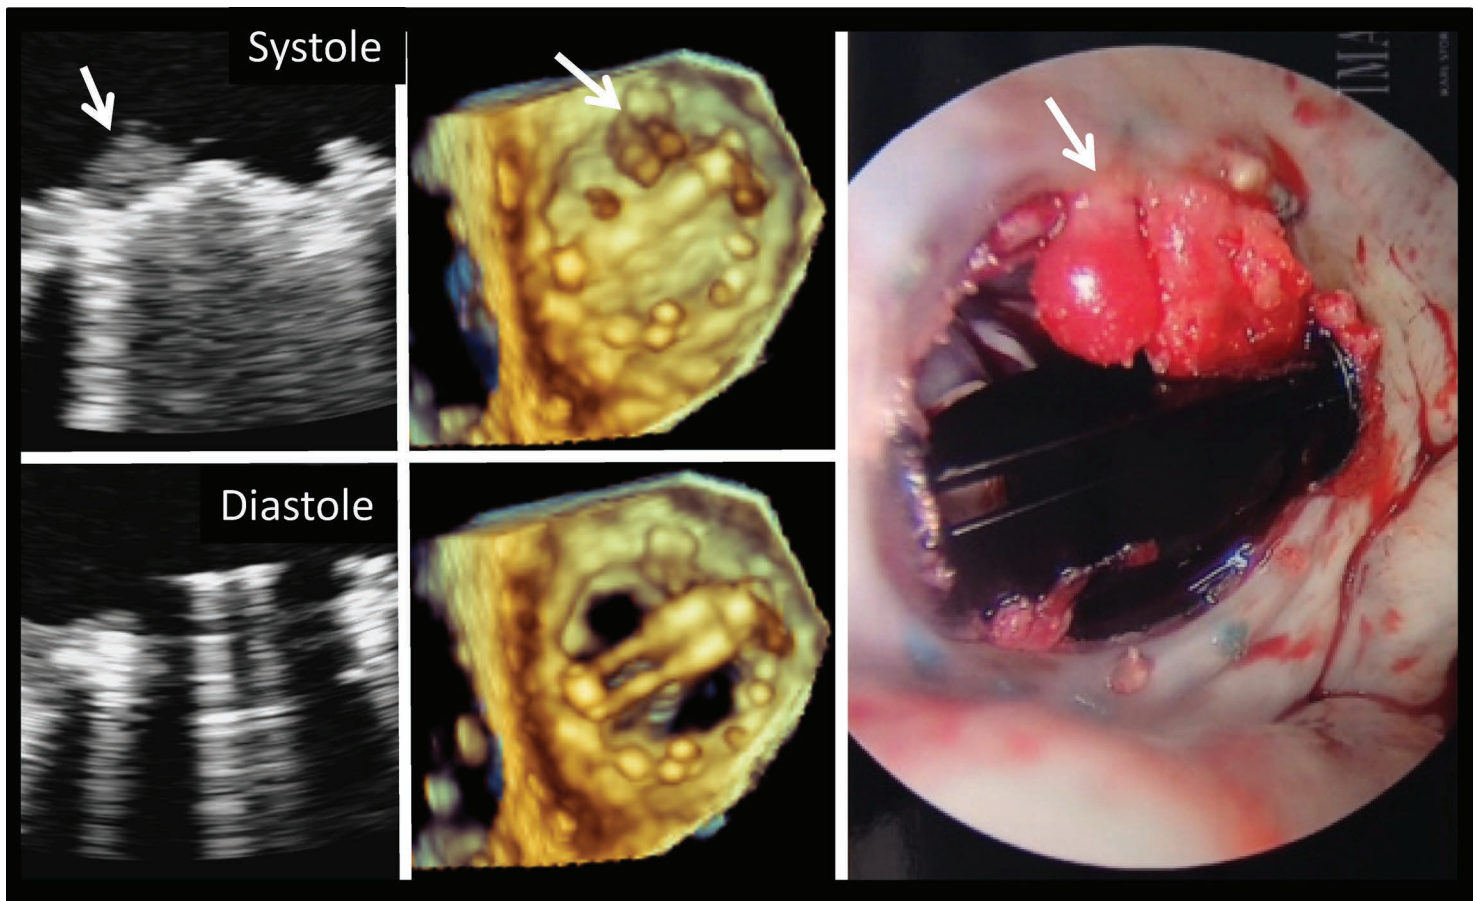
prompted evaluation of her mitral valve prosthesis. Two- and three-dimensional echocardiographic images demonstrated a large thrombus (arrow) on the mitral valve prosthesis. Intraoperative imaging confirmed echocardiographic findings.
