A Giant Aortic Root Abscess

UNIVERSITY OF NEBRASKA MEDICAL CENTER, OMAHA, NEBRASKA

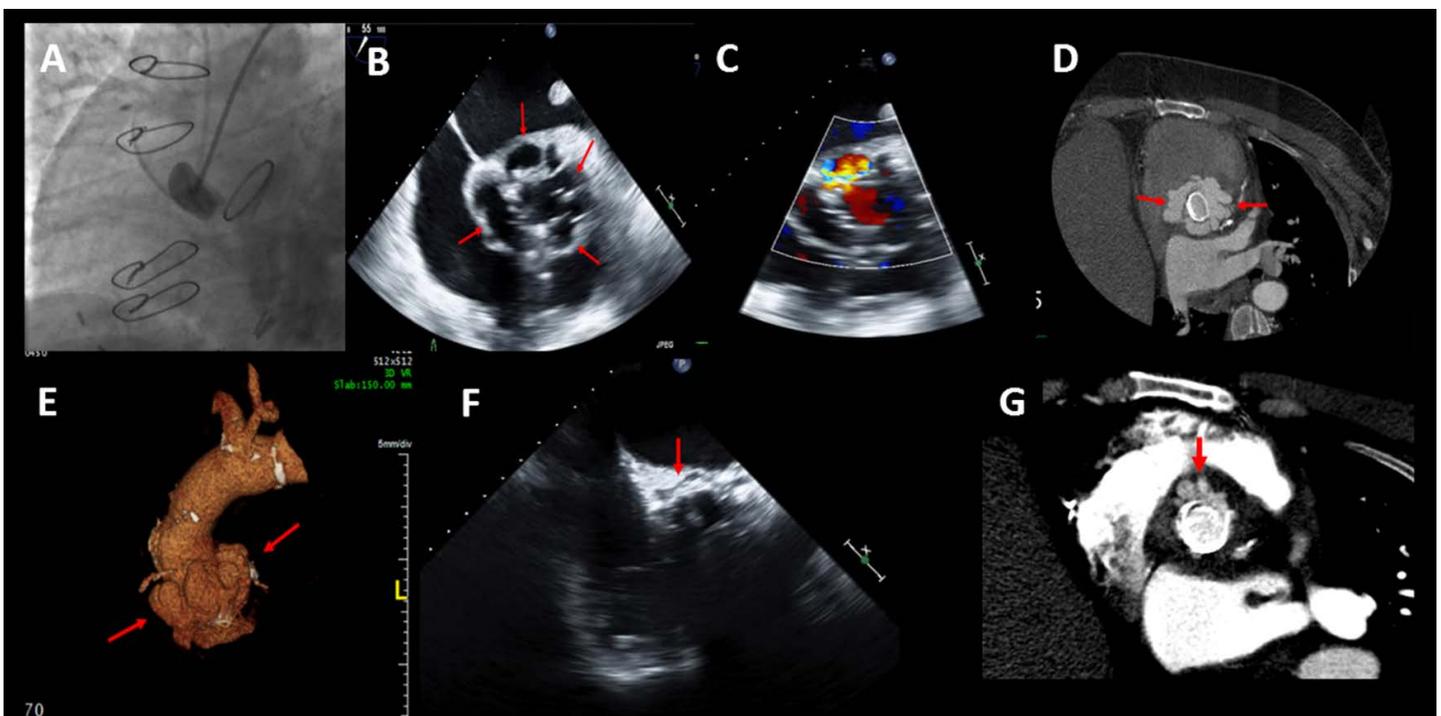
A 63-year-old male with a history of coronary artery disease and severe aortic stenosis status post mechanical aortic valve replacement and coronary artery bypass presented with atypical chest pain and group B streptococcal bacteremia. His transesophageal echo (TEE) was read as negative for vegetations, and chest computed tomography (CT) was reportedly unremarkable. He was started on antibiotics, and coronary angiography showed severe triple-vessel disease, patent left internal mammary artery graft, and complete occlusion in all vein grafts. Percutaneous intervention with stenting of the left anterior descending and circumflex artery was performed. During the diagnostic angiography, nonselective contrast injection showed an anterior aortic root “pouch” (A, Online video 1), but since the CT was unremarkable, no further investigation was done. A month later, the patient presented with fatigue and persistent bacteremia. TEE showed a large circumferential hypoechoic space with radial strands around the sewing ring of the mechanical valve (B) along with new moderate perivalvular leak (C). A CT scan showed extensive perivalvular and para-aortic contrast collections extending from below the aortic annulus to mid-ascending aorta, consistent

with abscesses/pseudoaneurysms (D, E). Both right and left coronary arteries were coursing through these abscesses/pseudoaneurysms (E, arrows). The mechanical valve was sitting on the abscesses and appeared to be dehiscent (D). Retrospective review of the initial TEE (F) and CT (G) showed evidence of aortic root infection (arrows). The patient underwent aortic root repair and aortic valve replacement. An aortic root pathology specimen showed fibrous growth with calcification and focal acute and chronic inflammation. After a complicated hospital course, the patient was discharged to a rehabilitation facility. Meticulous evaluation with imaging and high index of suspicion is necessary when there is a question about infection in patients with prosthetic valves.
